New York State Department of Transportation

PIA Safety Flag NB23CTW010

BIN: 1065318

This PIA Safety Flag No. NB23CTW010 is a New Flag.
Location: Span 158, Pier 157, Column C2 at the base.

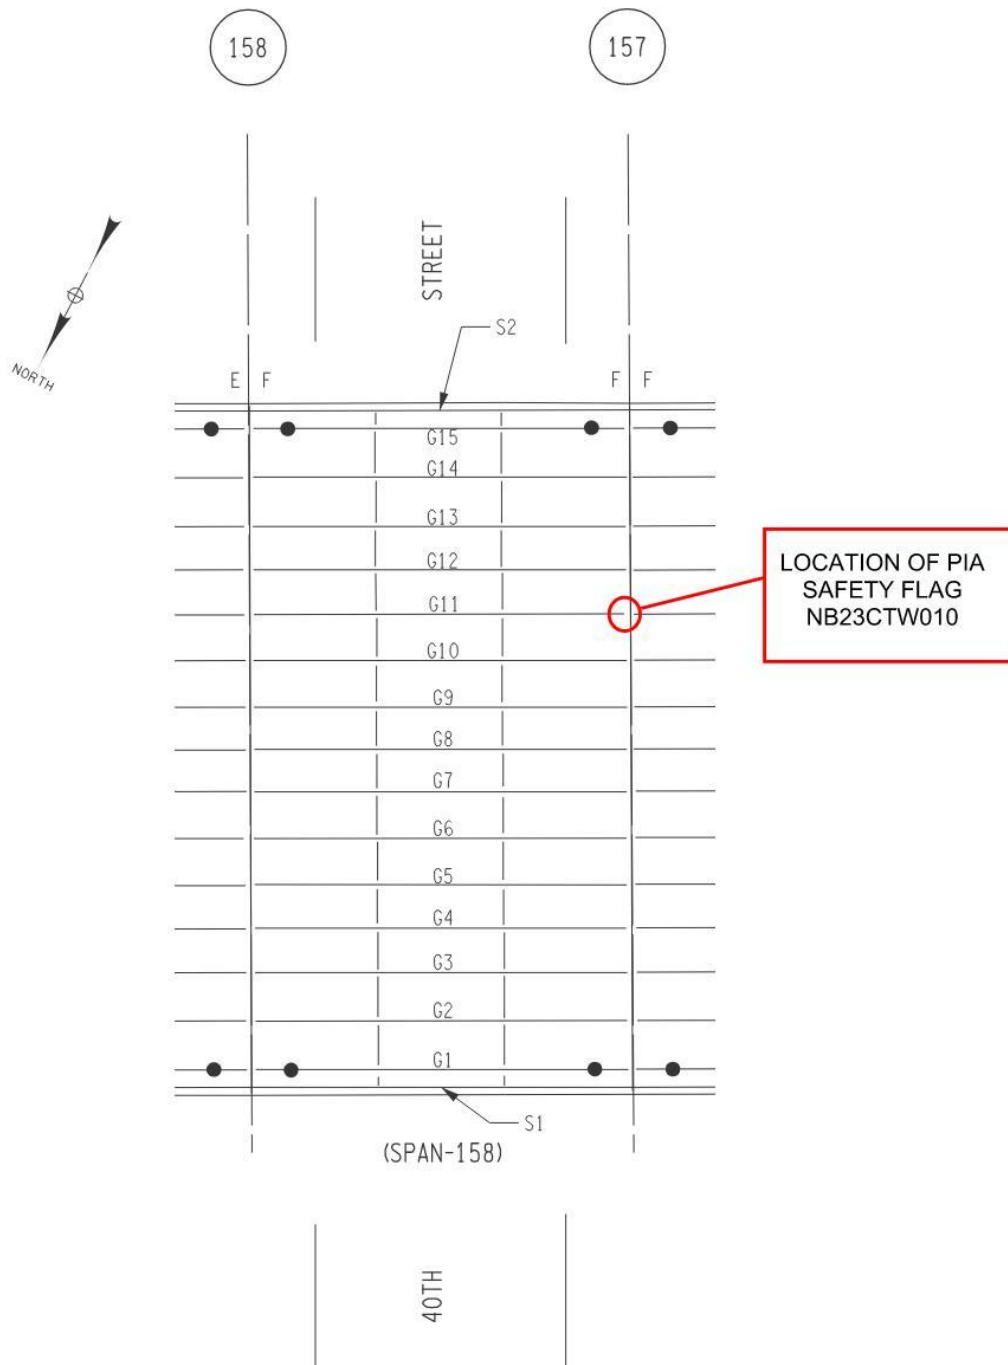
Flag PhotographsPhoto Number: **1**Photo Filename: **Flag Location - Span 158 RA.jpg**

**Attachment Description: Flag Location Plan.**

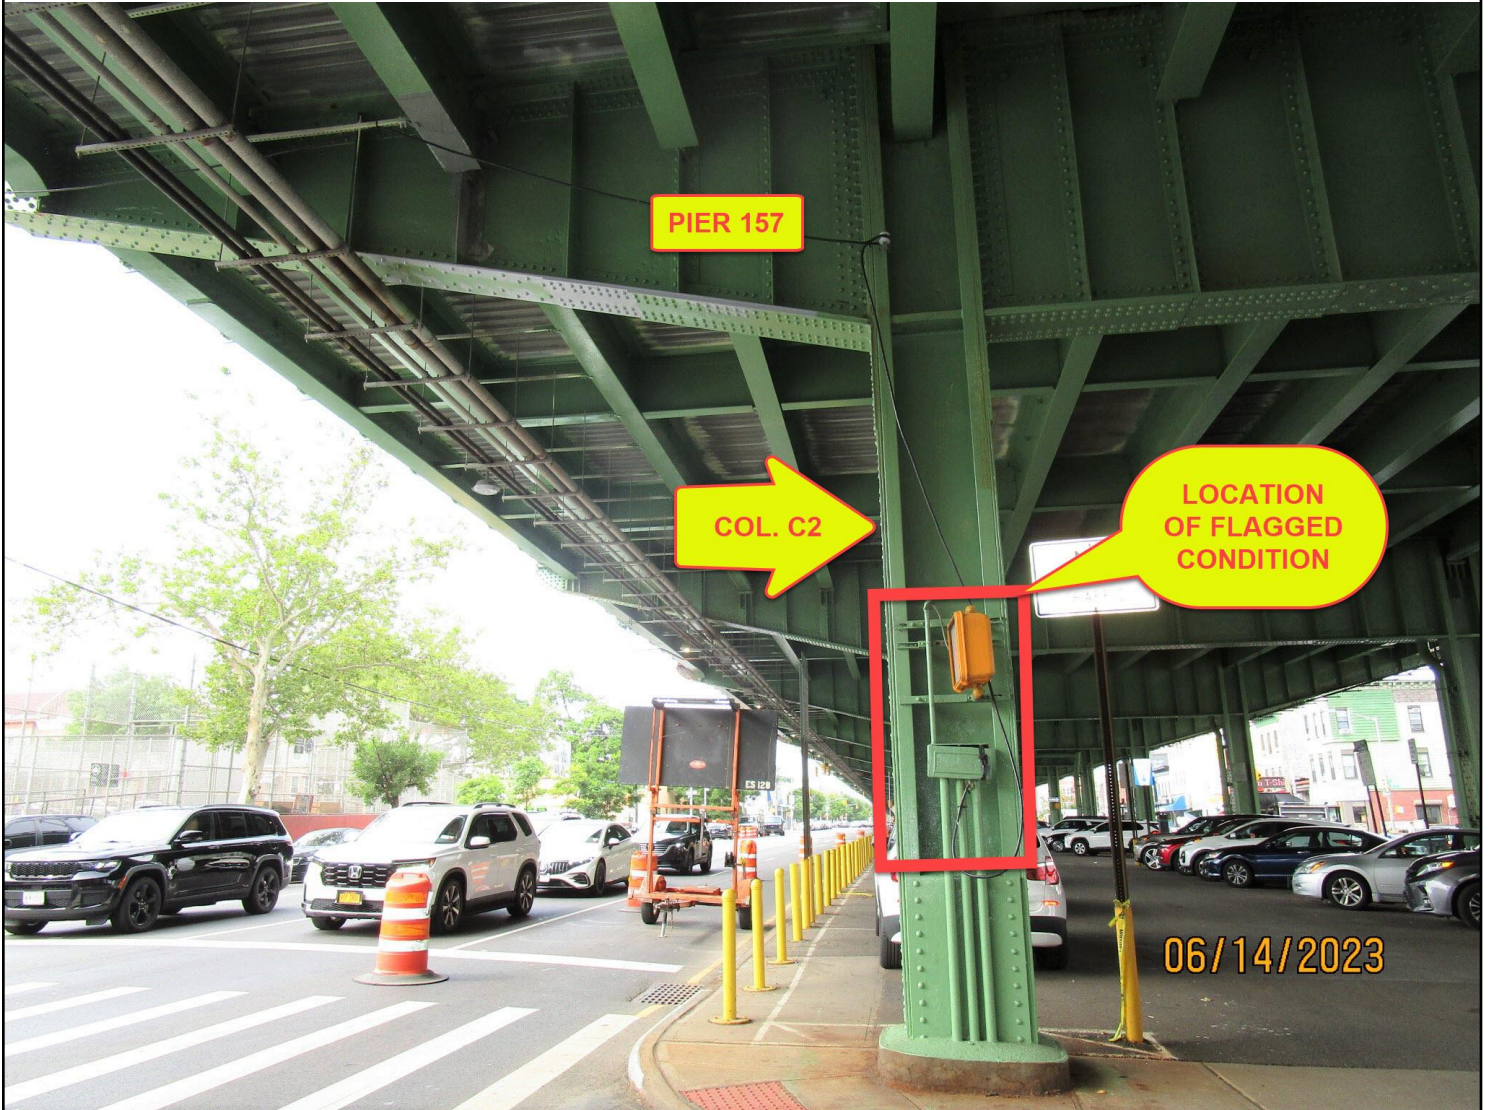
Photo Number: 2

Attachment Description: General view of Flagged location. Looking Begin.

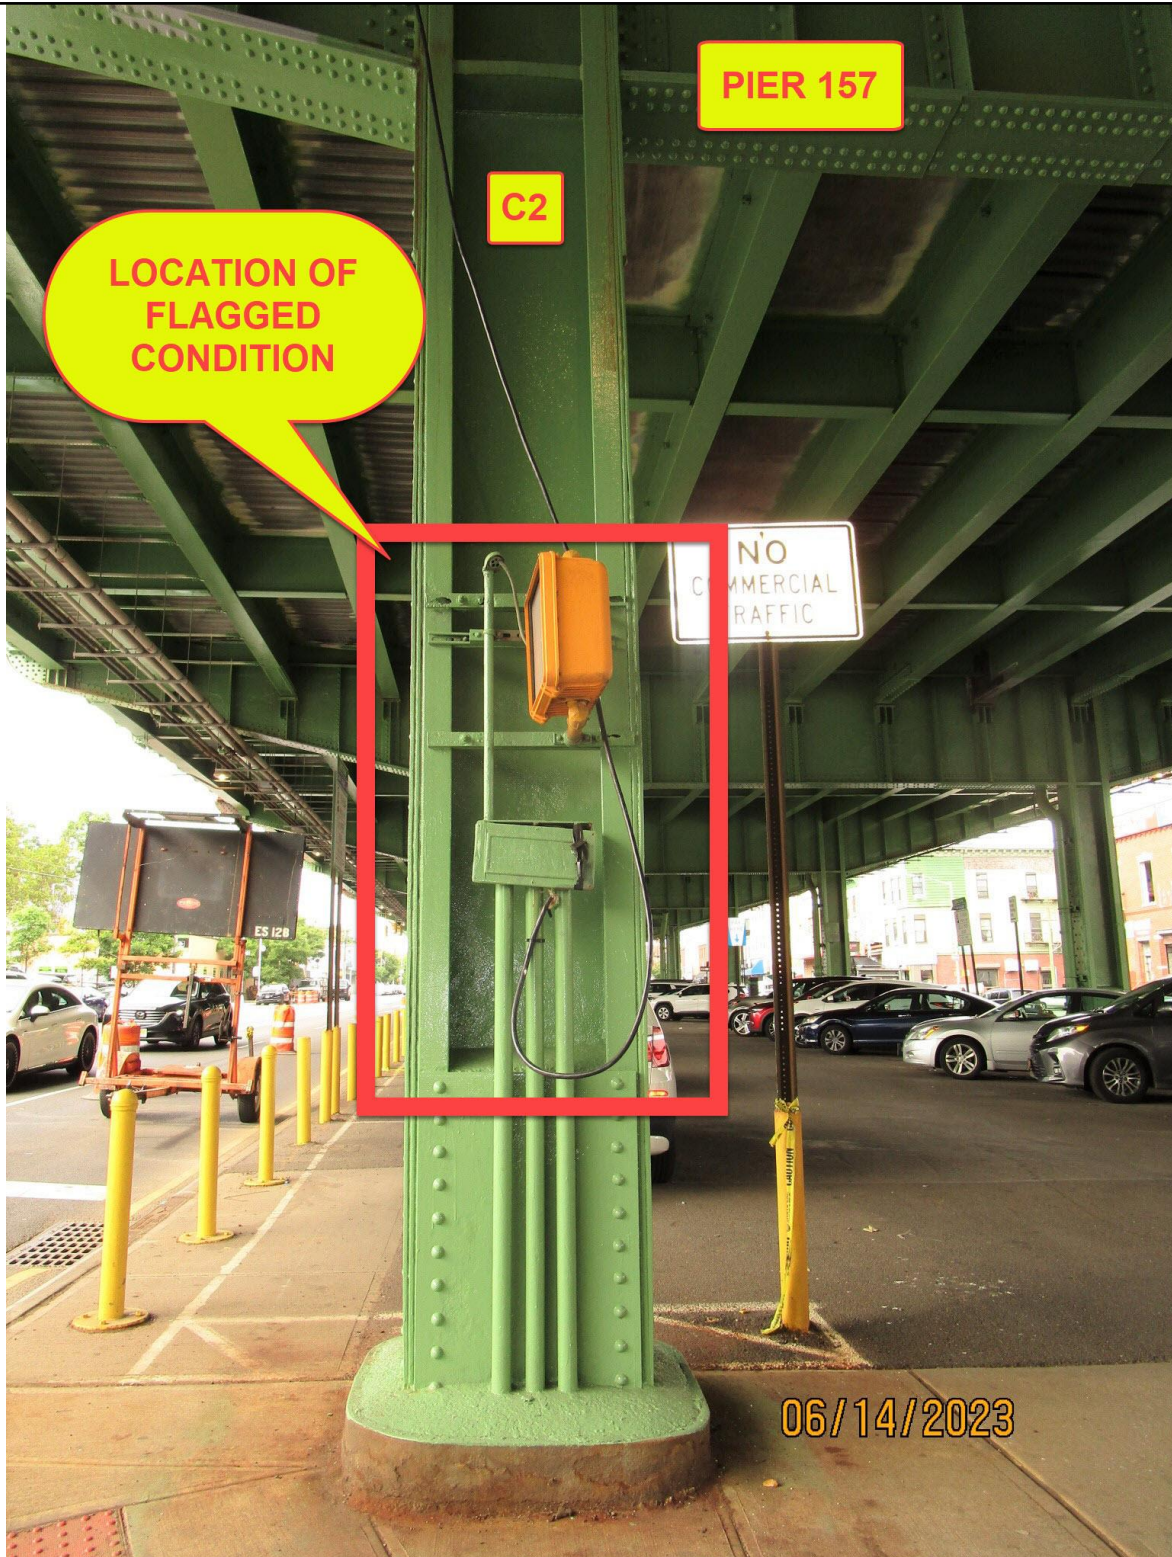
Photo Number: 3

At Span 158, Pier 157 Column C2, End face, there is a broken electrical junction box which exhibits exposed live wires. The condition is at the base of the column, and is accessible by the public.

Attachment Description: Location of Flagged condition at Pier 157, Column C2. Looking Begin.

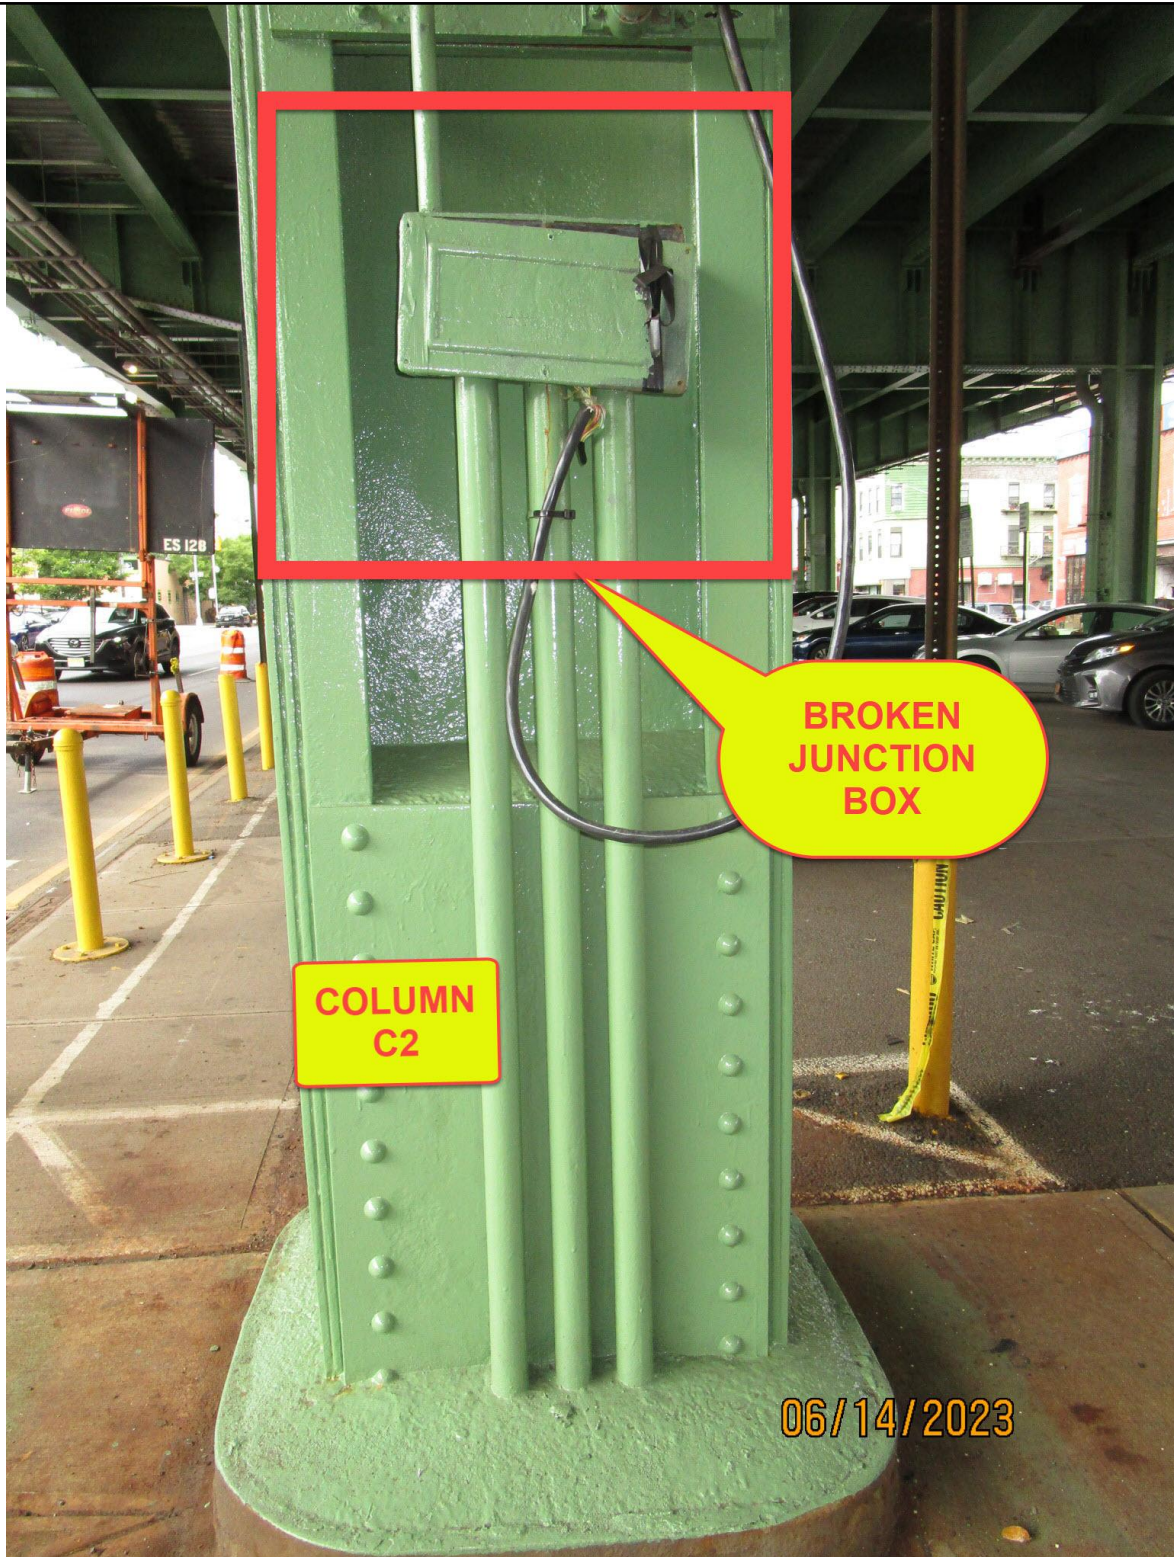
Photo Number: 4

Attachment Description: Close-up view of the broken junction box at Column C2. Looking Begin.

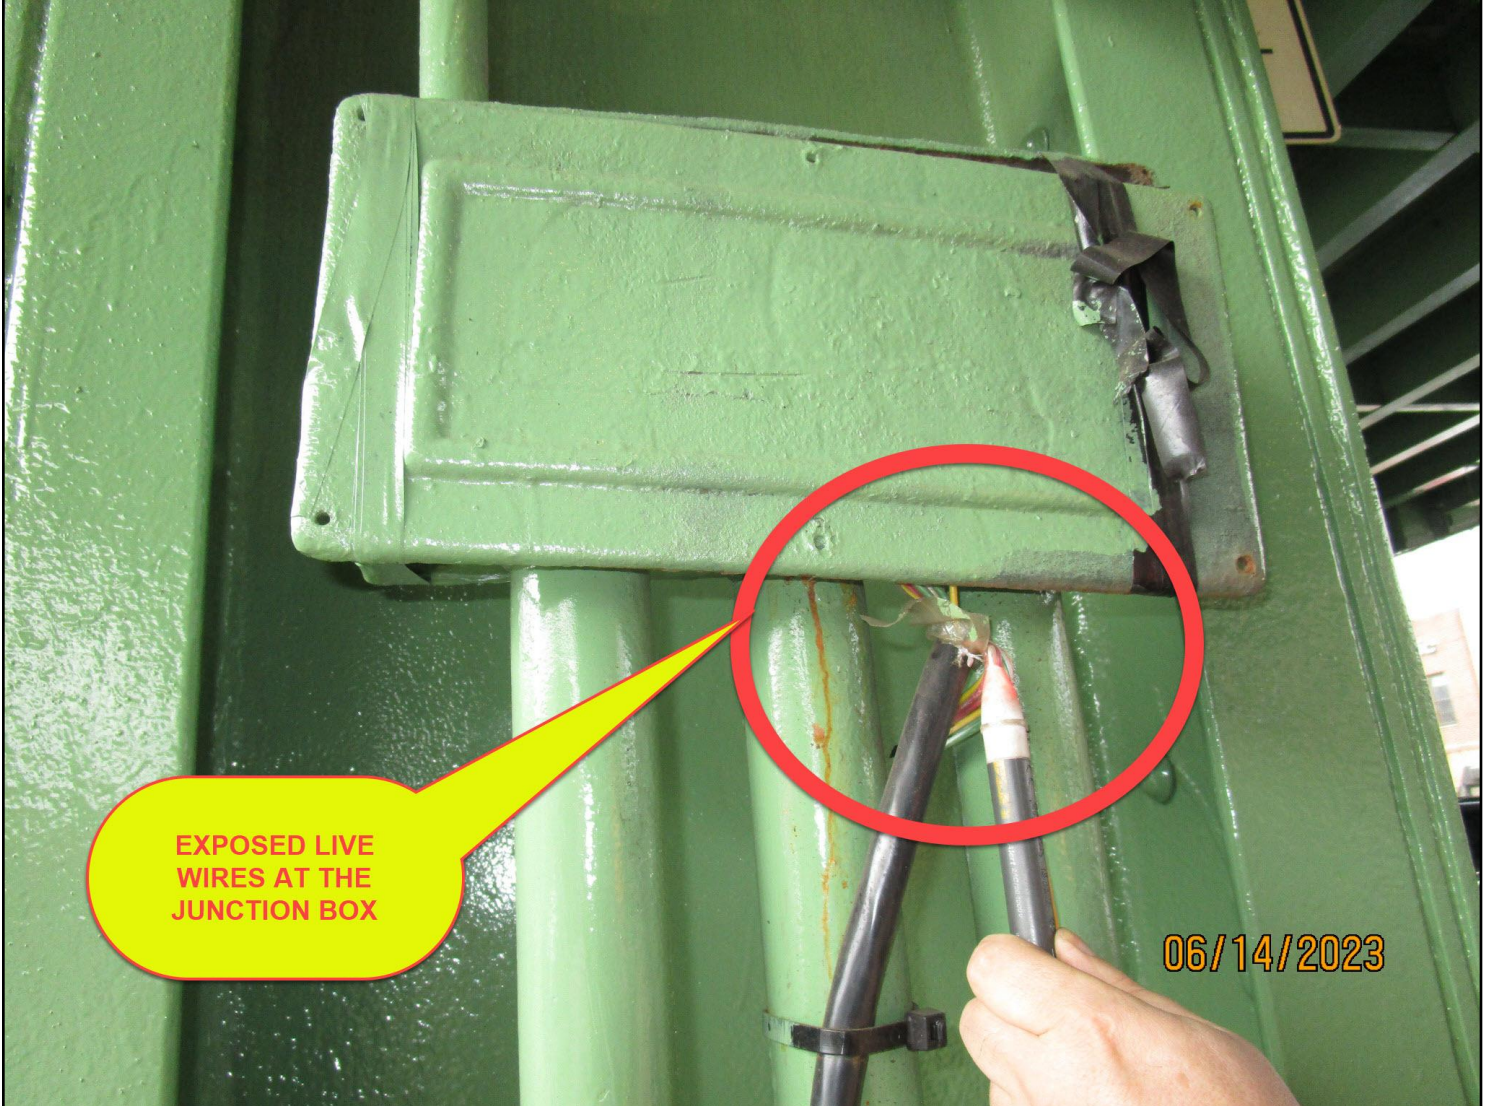
Photo Number: 5

Attachment Description: Non-contact voltage detector indicates live wires at the junction box. Looking Begin.
